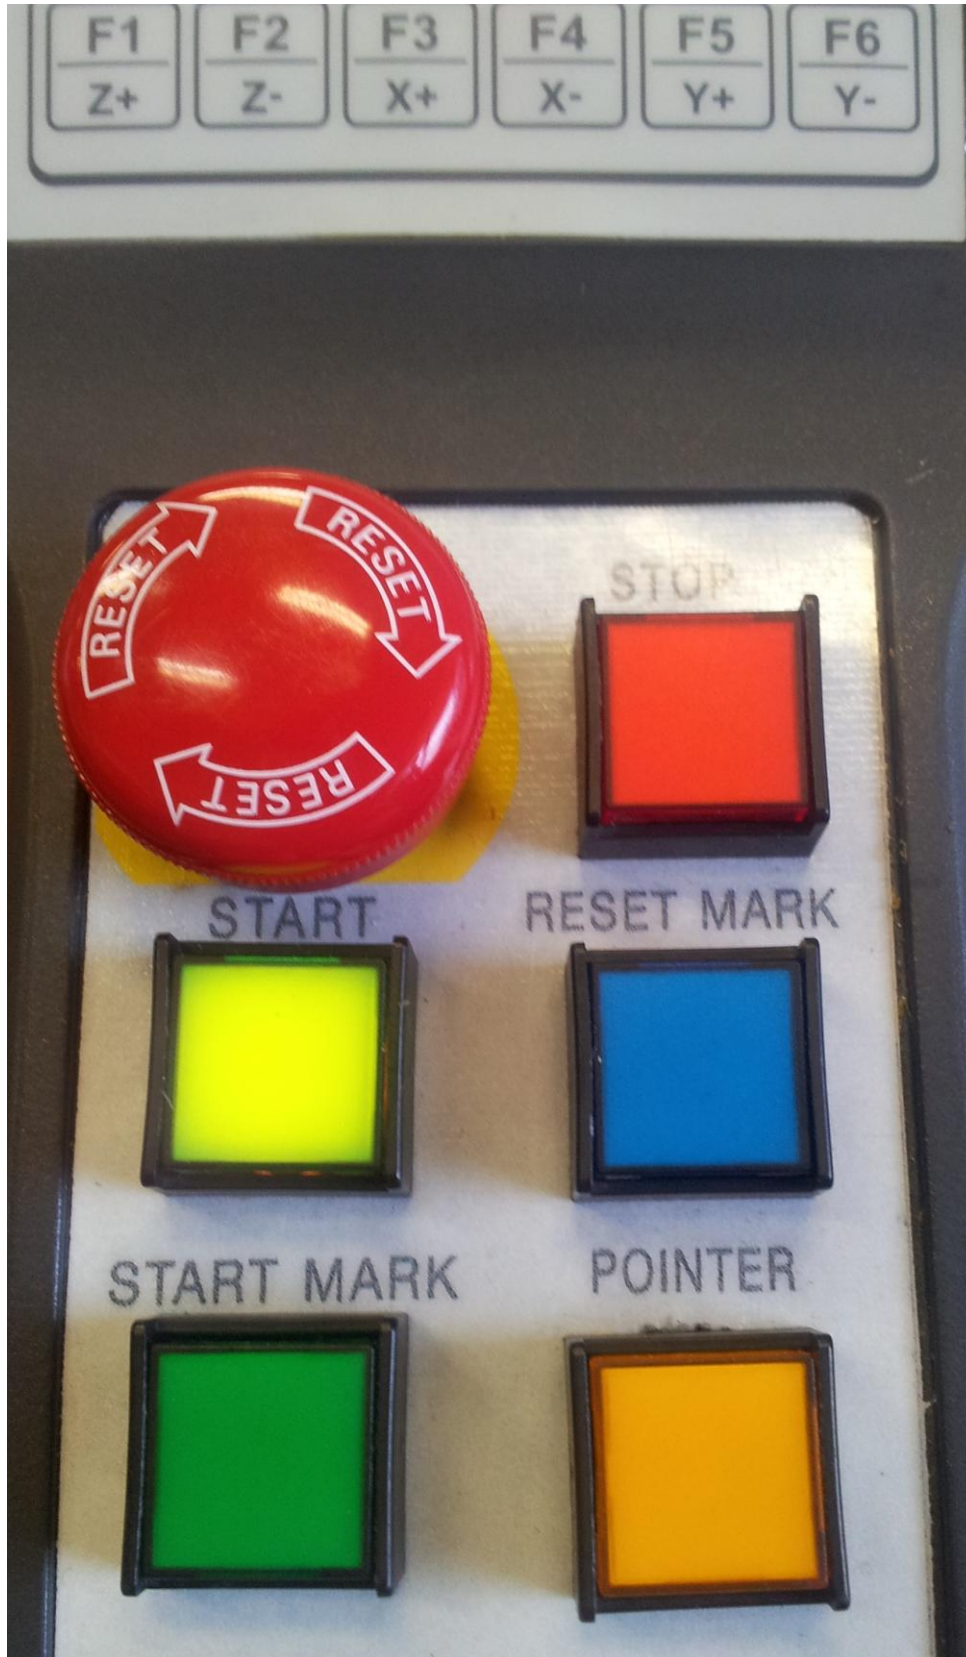
54. If there aren't any alarms, the laser turn on: green led turn on

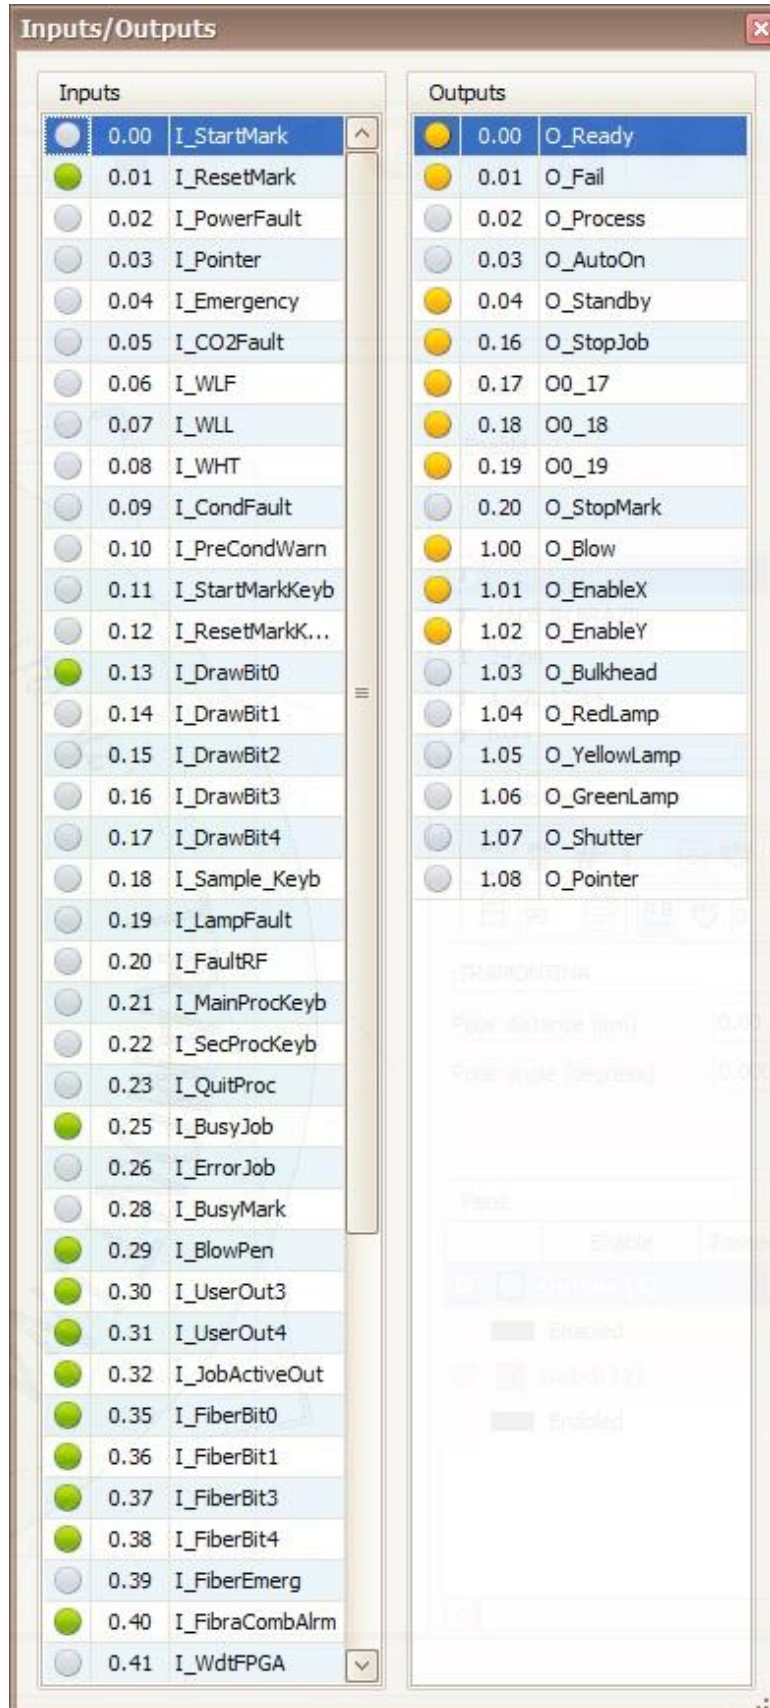
55. If ResetMark from the master is enabled (+0V) then the Led I_ResetMark is in high state

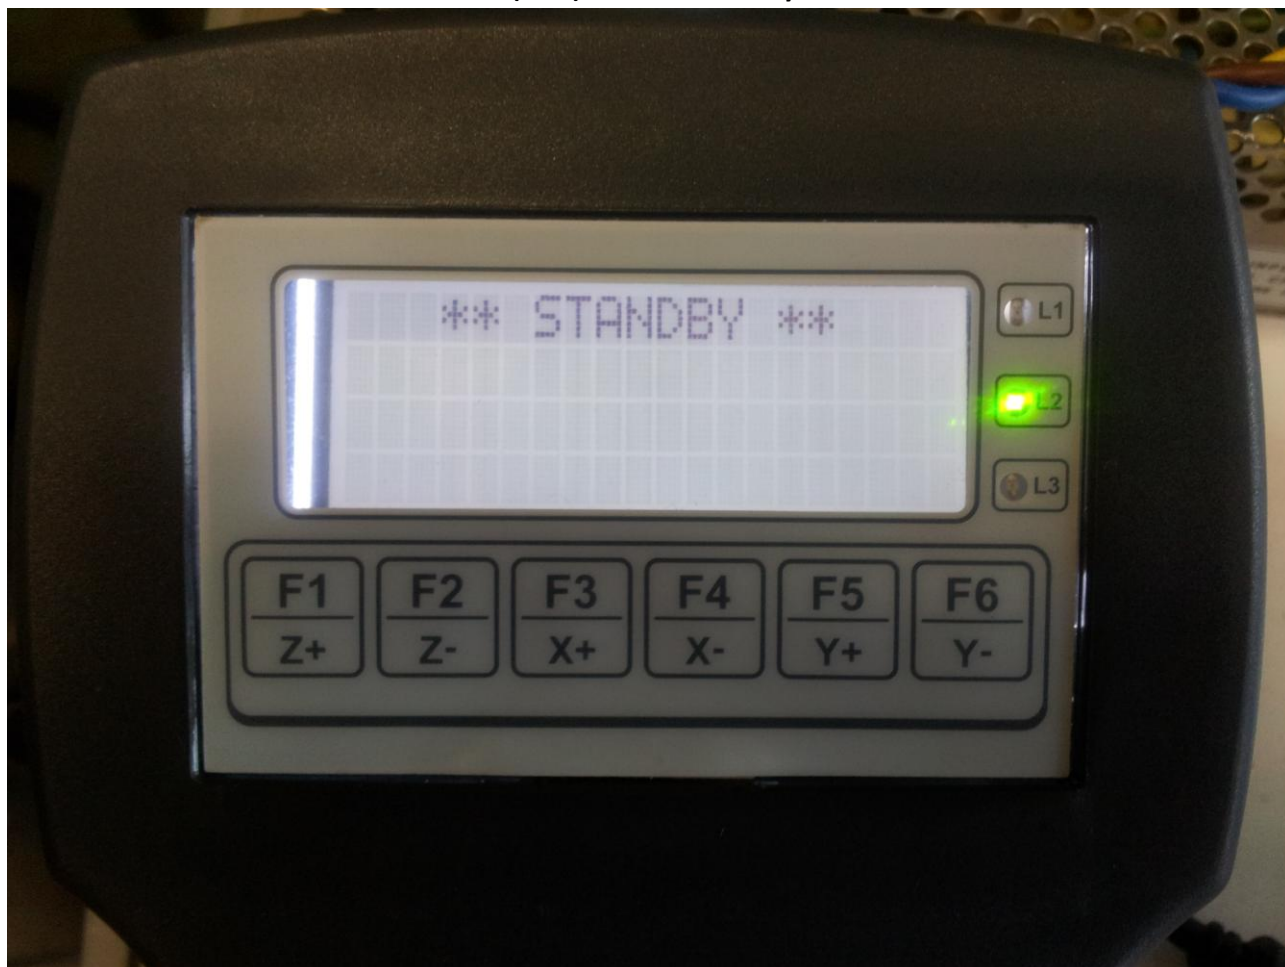
56. If Reset Mark from the master is enabled (+0V) then the LCD Keyboard shows "STANDBY"

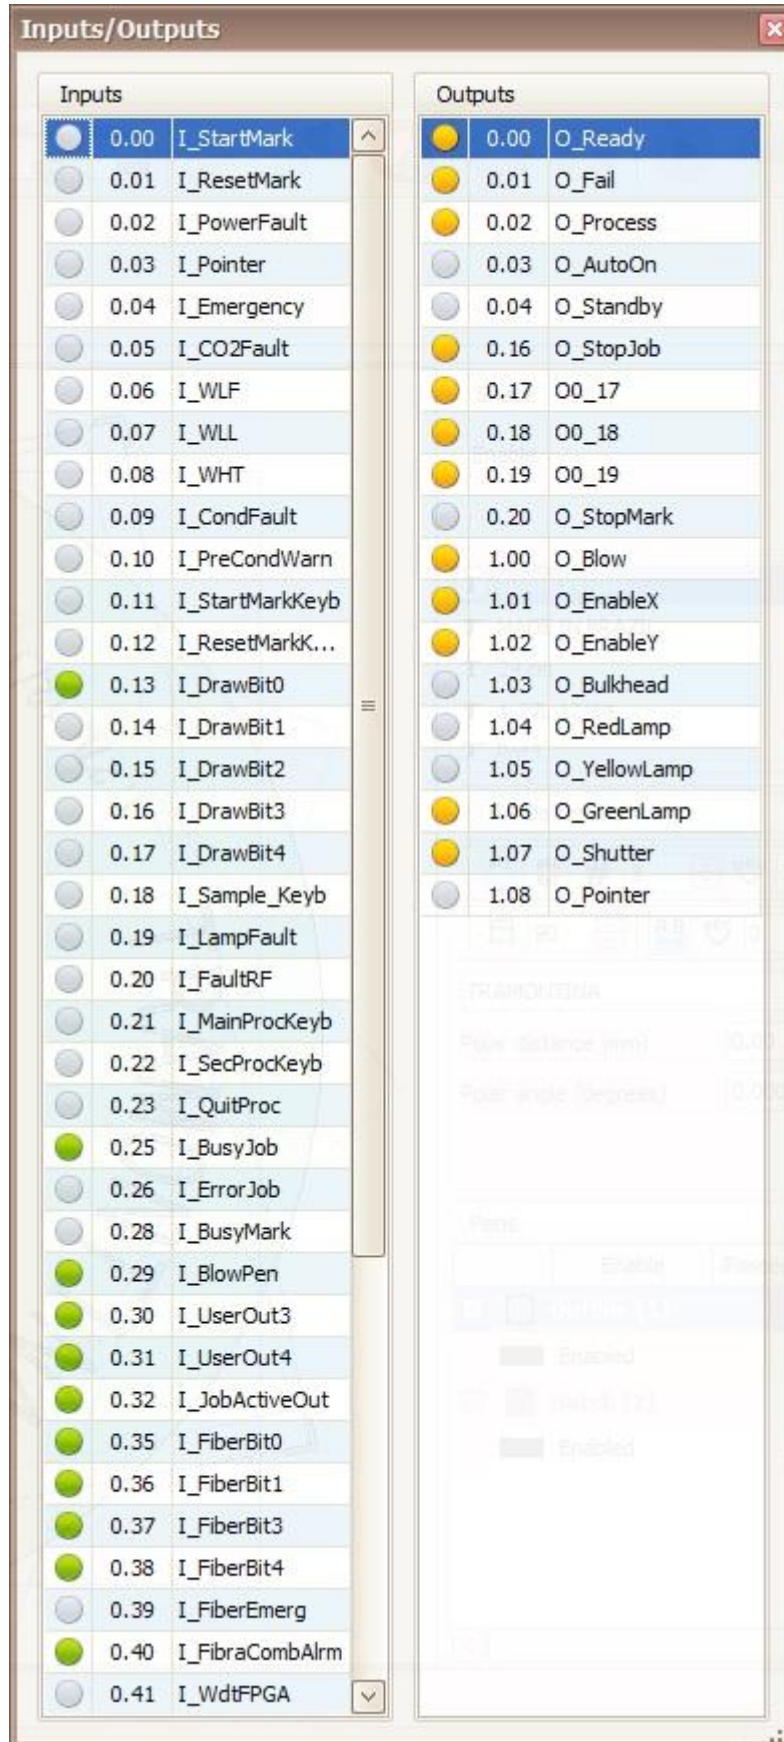
57. Disable Reset Mark from the master (put it to +24V). In IO Status, I_ResetMark is low

O_Process is high

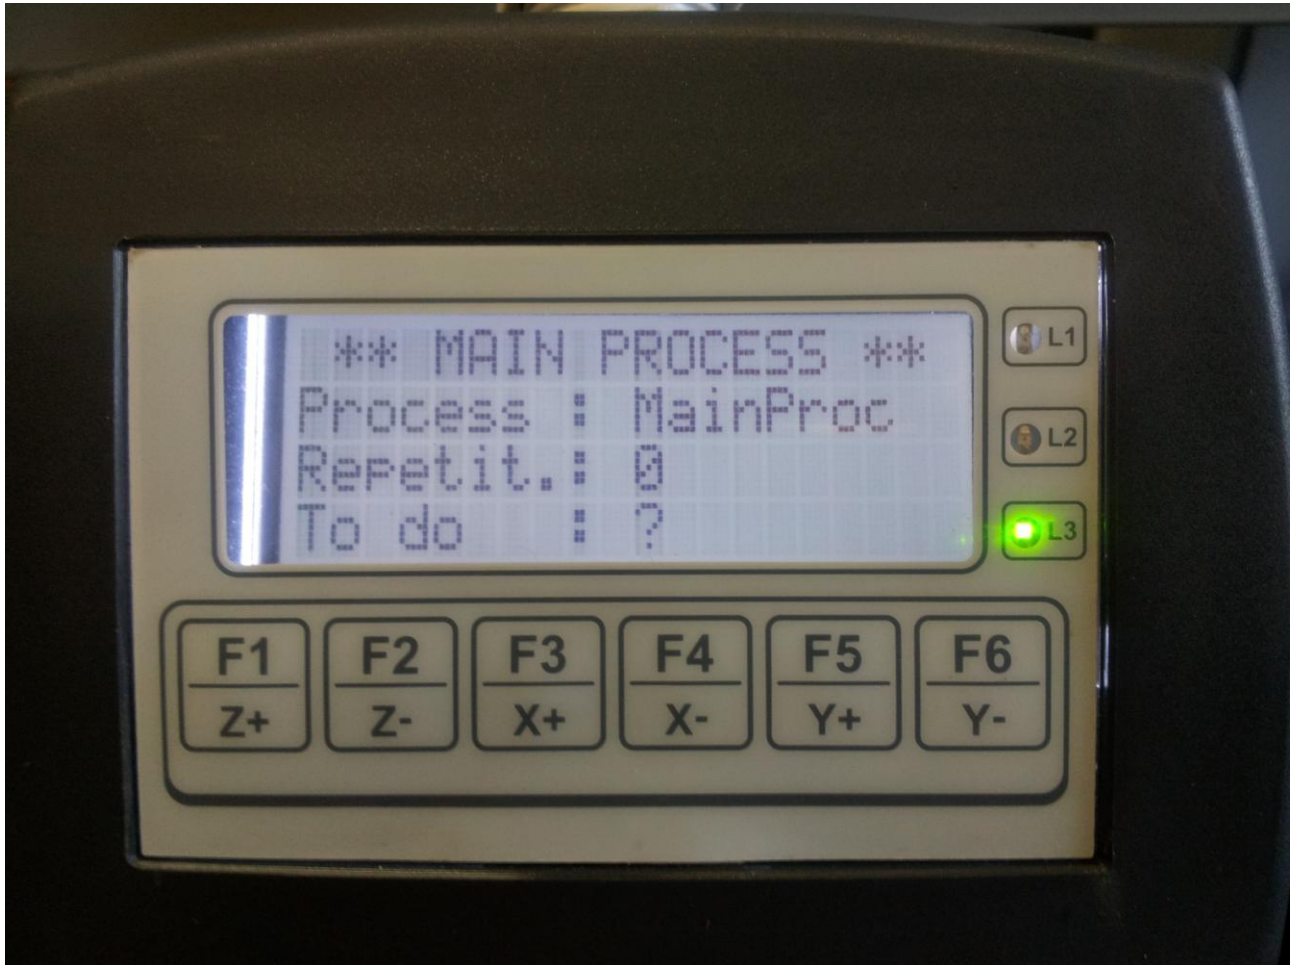
58. The LCD Keyboard shows "MAIN PROCESS"

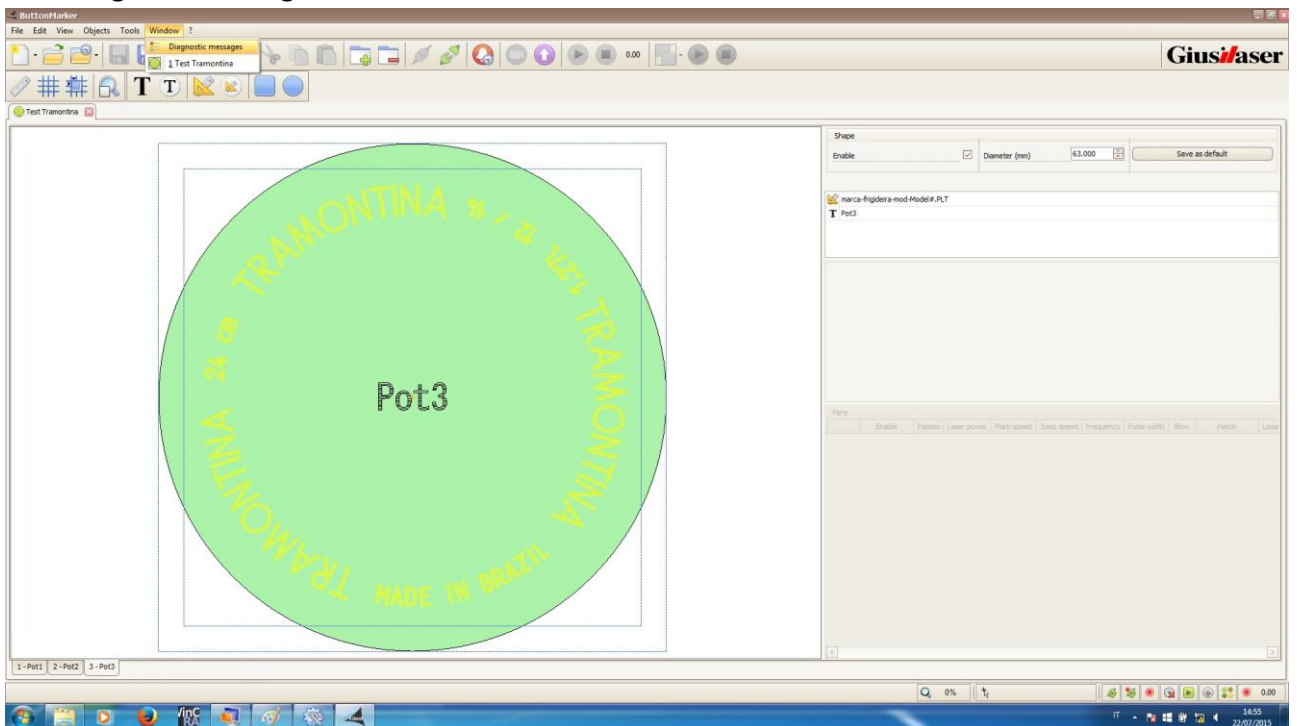
59. Press diagnostic messages

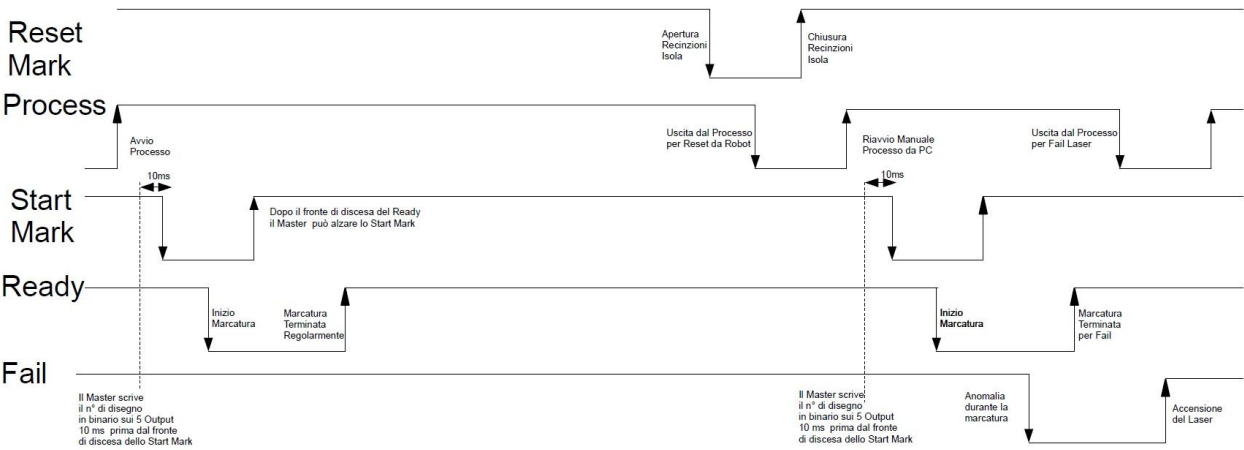
64. This is the process diagram
